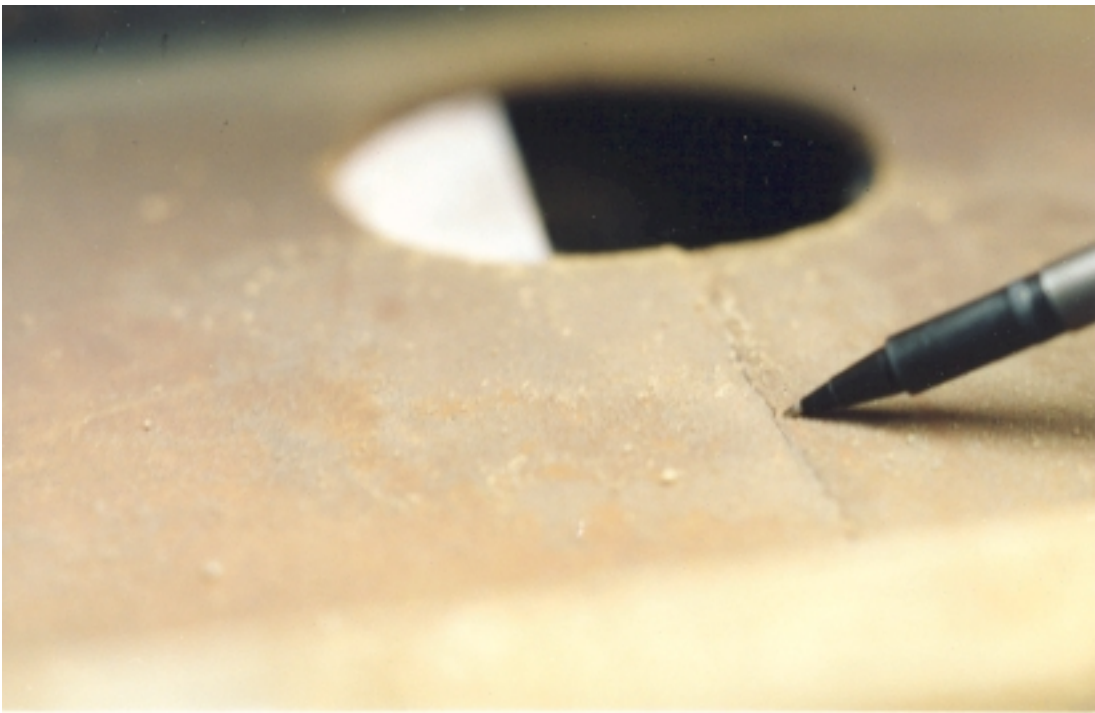
Photograph 17
P01. Cracked baffle in the Catalytic Trailblazer Genesis 2000.

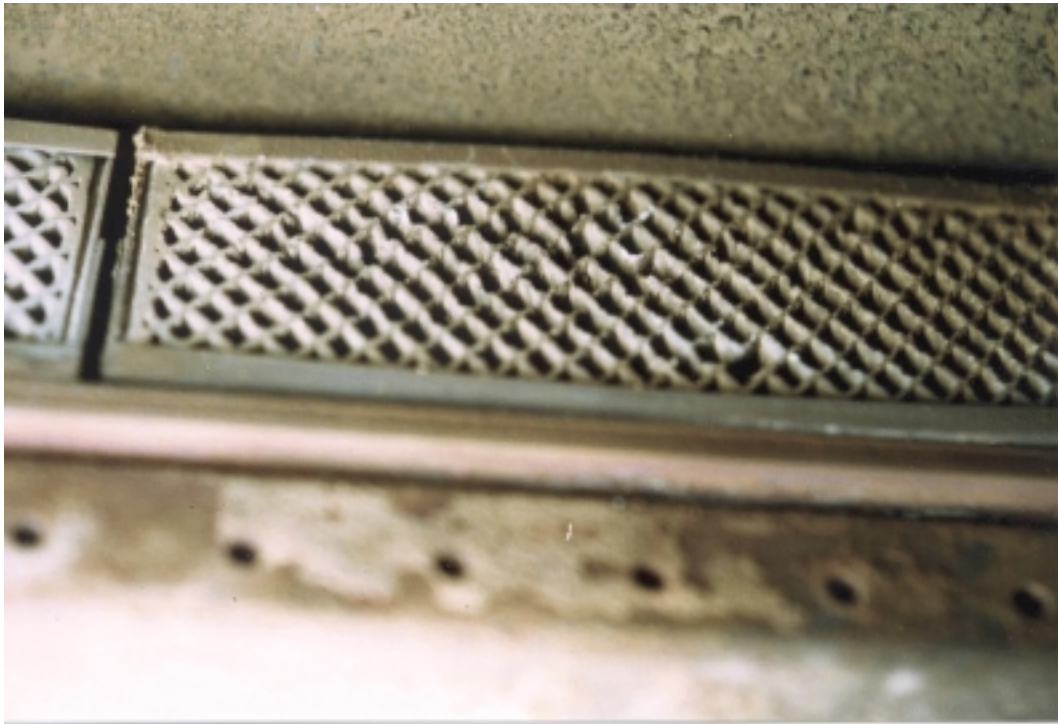
Photograph 18
P01. Degraded catalyst in the Catalytic Trailblazer Genesis 2000.

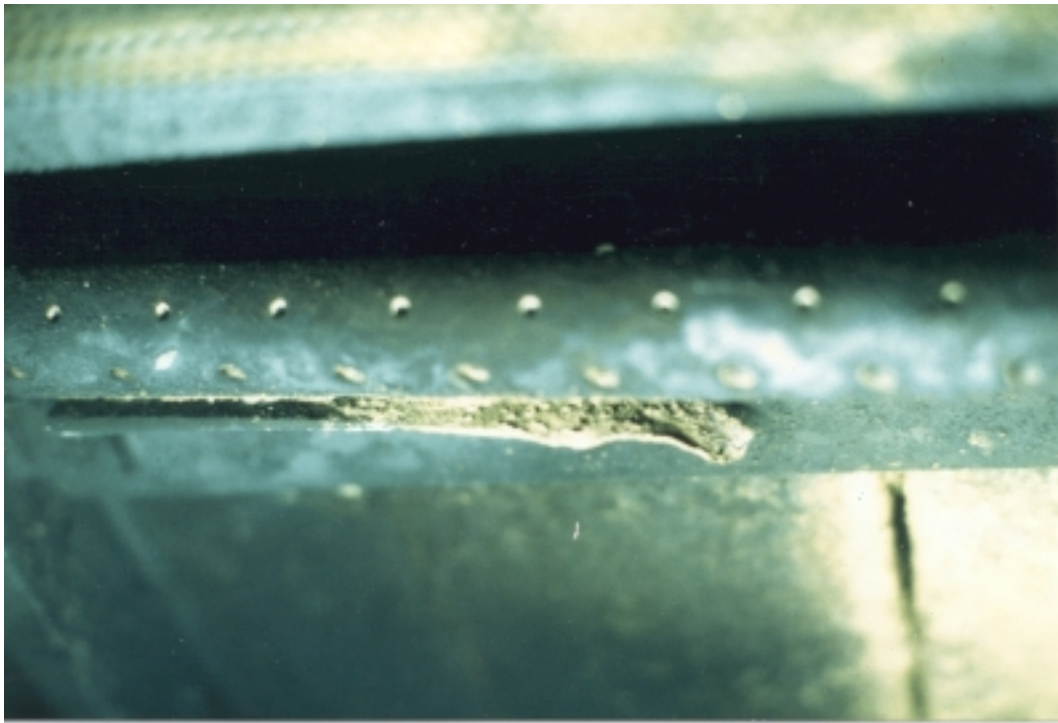
Photograph 20

P02. Degraded support for the front secondary air tube in the non-catalytic Lopi Answer Series.

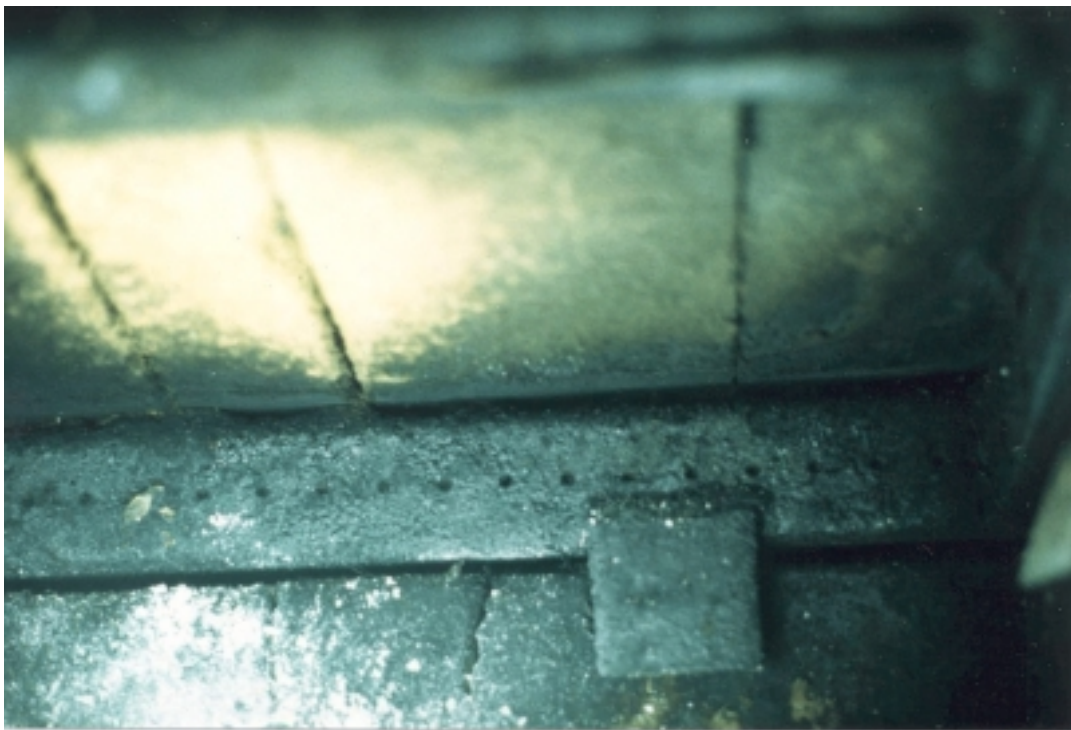
Photograph 21

P02. Creosote deposits on the secondary air tube in the non-catalytic Lopi Answer Series.

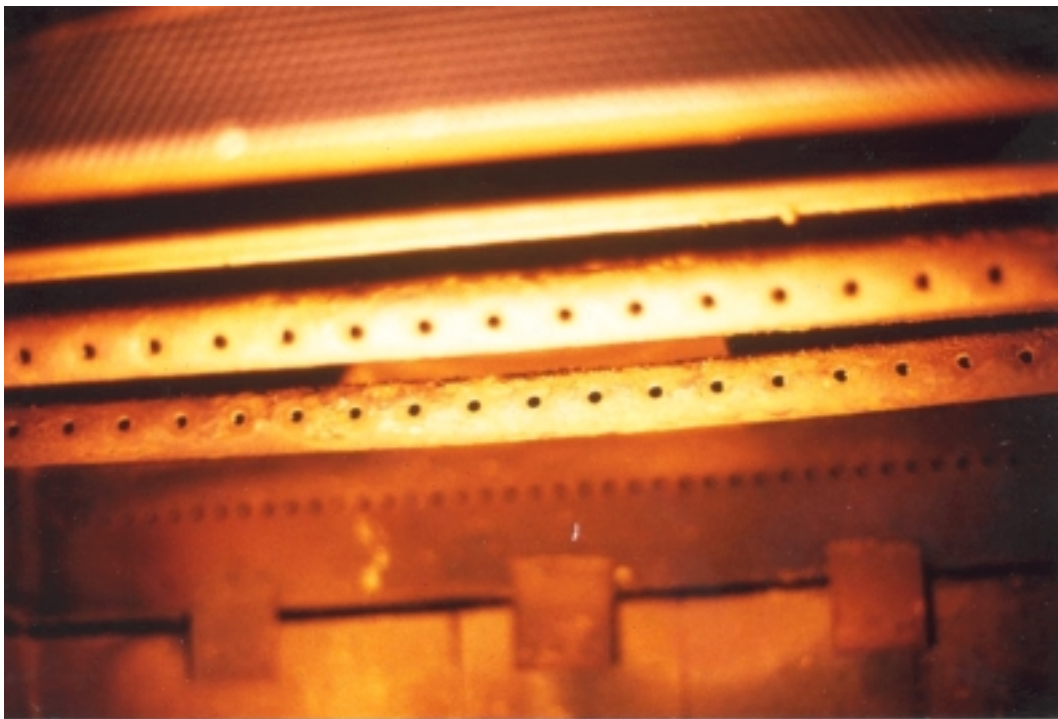
Photograph 24
P04. Warped and flaking secondary air tube in the Catalytic Flush Bay-96.

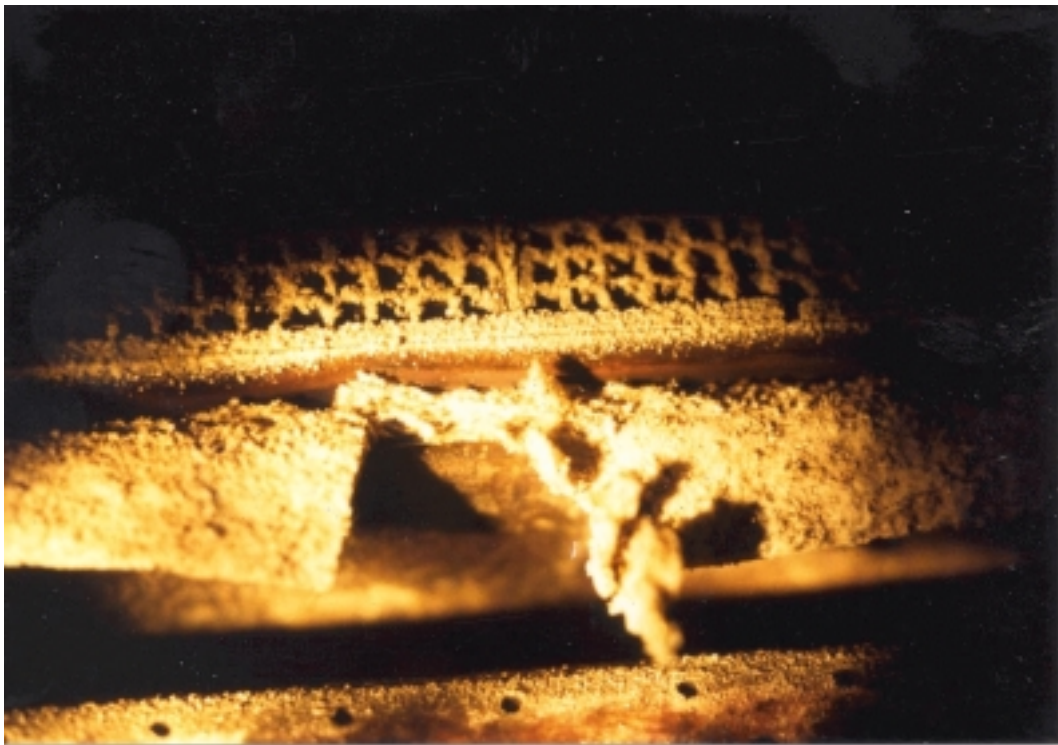
Photograph 26
P05. Disturbed catalyst interam seal in the Catalytic Flex-95.

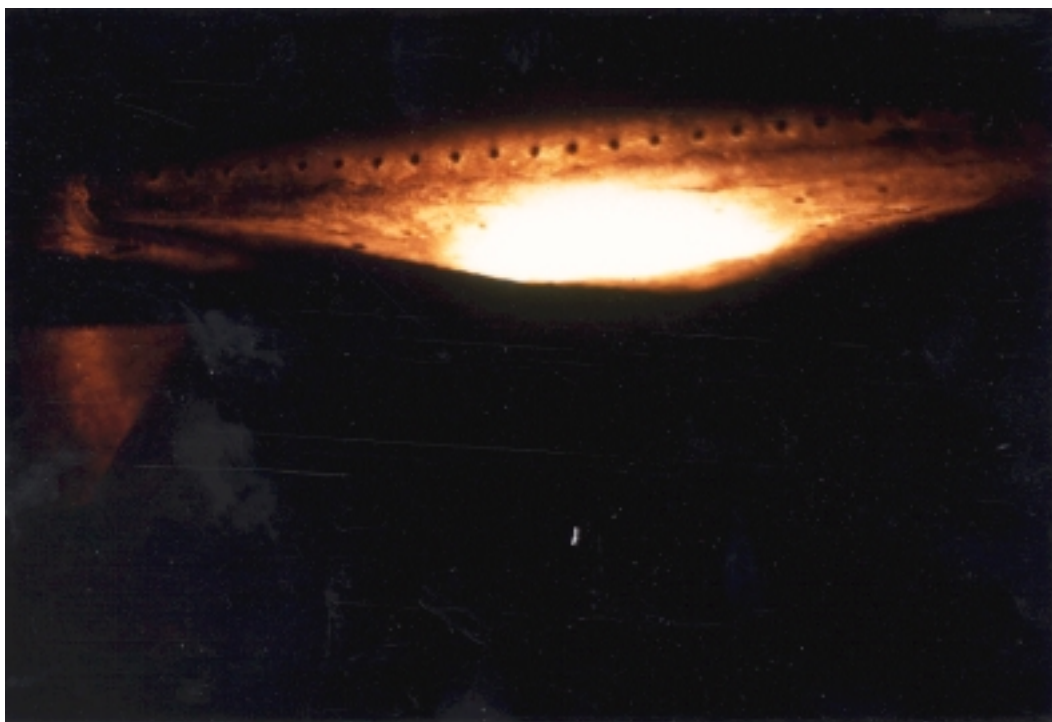
Photograph 28
P06. Sagging baffle in the non-catalytic Pacific Energy Super 27

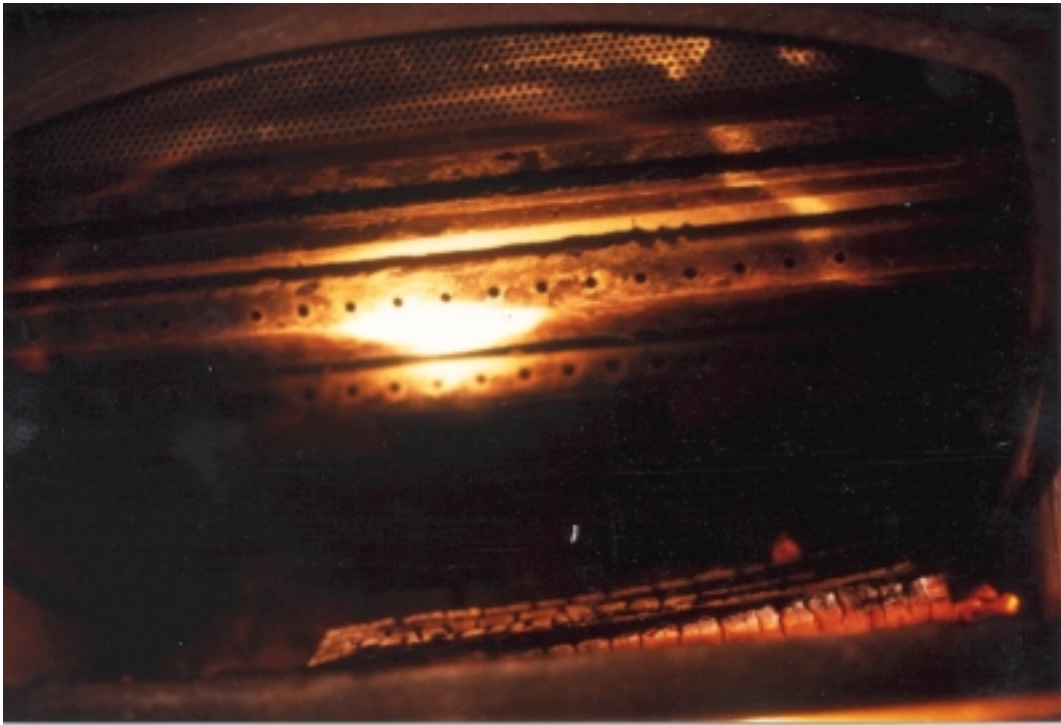
Photograph 30
P07. Flaking secondary air tube in the non-catalytic Lopi 520-96.
